On the Need to Conduct Additional Stress Tests to Evaluate the Safety of the Hydraulic Structures Site at the Zaporizhzhia NPP

Purpose. Conducting a comprehensive analysis concerning the condition of the cooling pond dam at the Zaporizhzhia Nuclear Power Plant (NPP), which is a key component in the hydraulic structures system at this NPP, to justify further research. Additionally, identifying any extra or previously unaccounted factors that could affect the overall safety of the structure. **Methodology.** The authors performed a comprehensive review of all available engineering surveys and geotechnical research materials related to the Zaporizhzhia NPP cooling pond dam. These materials were produced by various organizations starting from the completion of the facility in 1985, with particular focus on the period 2011–2018, especially after the publication of the 2011 stress test report. Special attention was given to high-precision geodetic data on settlements and deformations of grades on the cooling pond dam. This enabled a new perspective on the findings of the engineering and geological surveys, as well as the stress tests conducted based on them. **Findings.** Based on the a

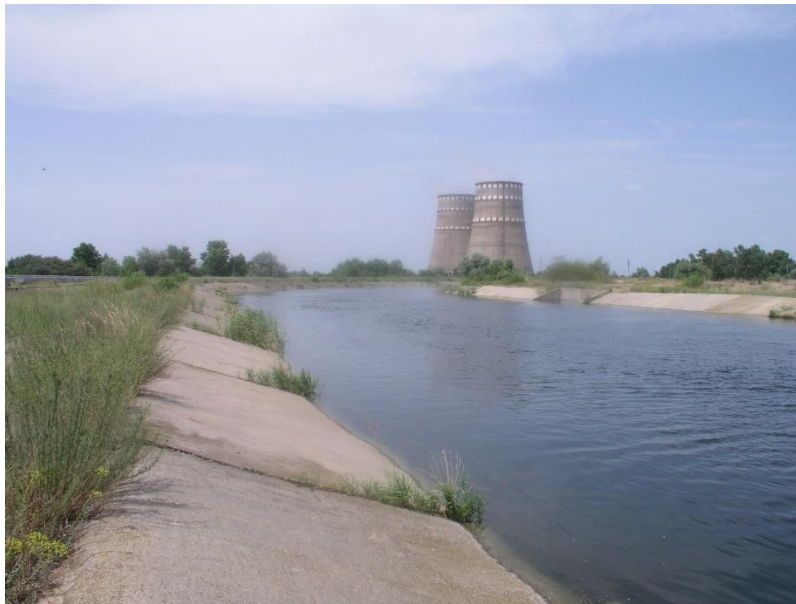
Fig. 1. The tail-water channel from the cooling towers on the dam of the Zaporizhzhia NPP cooling pond (photo 2010)

1.3 re-profiling of the upper part of the prism (displacement of soil masses, formation of benches) in the area between the outlet channel from the cooling towers (the highway and the shoreline);

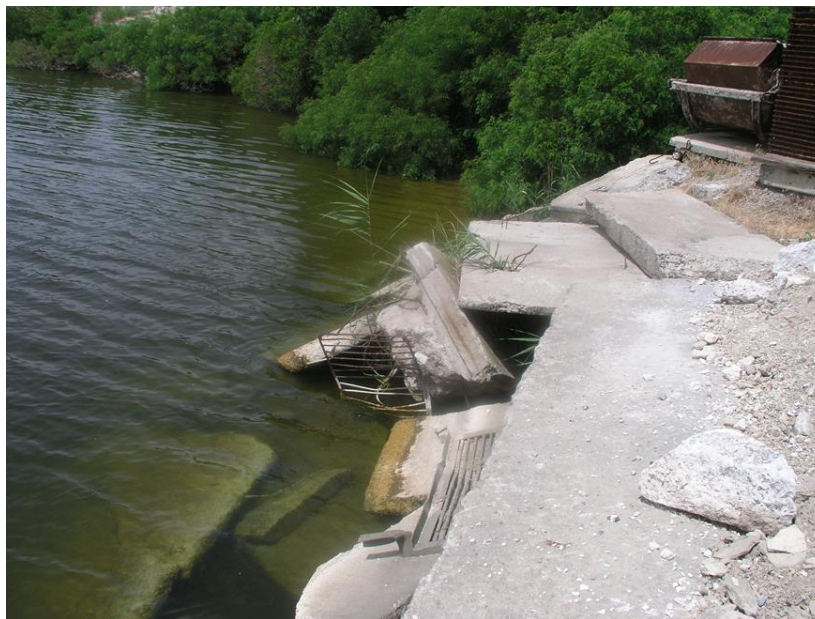
Modern geological and engineering-geological processes and phenomena. During the operation of hydraulic structures, negative man-made processes were recorded. In 1993, the slope of the bucket adjacent to pumping station No. 1 on the side of the spray ponds collapsed. In the spring of 1993, a landslide of the coastal ledge made of loose backfill sand was recorded at the dam of the cooling pond at the junction with the pumping station supplying water to the cooling towers. In both of these cases, the causes of the landslide processes were not fully clarified. The coastal slopes near pumping station No. 1 continue to be in an emergency condition to this day (2014), negative man-made processes are manifested in the form of collapse (sliding) of the coastal zone, destruction of the building's blind area, and subsidence of the concrete slope.

Fig. 3. Destruction of the slope fastening at the pumping station supplying water to the cooling towers (photo 2010)

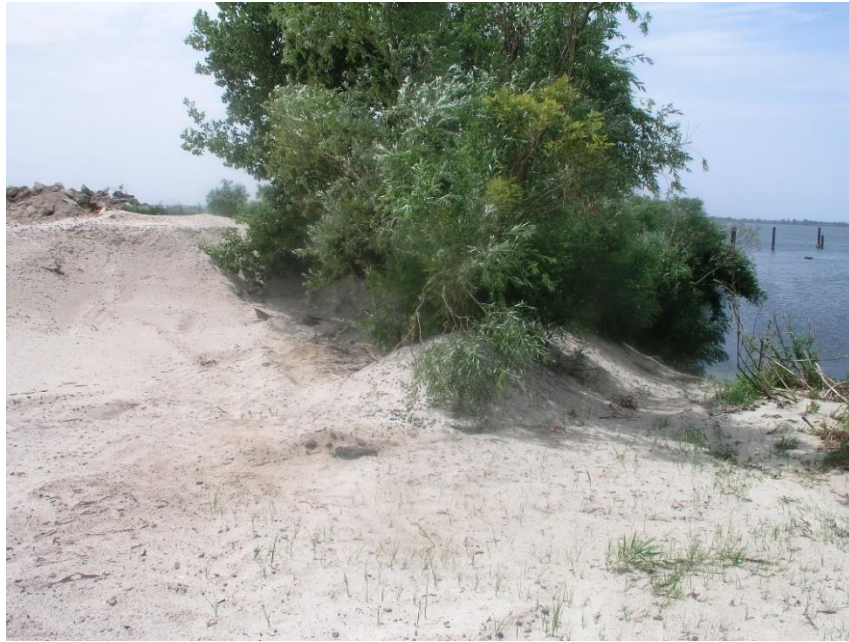
1.4 processing of the shoreline of the outer slope of the dam (erosion of slopes, formation of beaches) in places where there is no or deformation of rubble fill;

1.5 intensification of the processes of processing the shoreline of the outer slope of the dam (formation of benches and terraces);

Fig. 4. Reworking of the coastal slope of the cooling pond dam from the side of the Kakhovka Reservoir (photo 2010)
