INVESTIGATION OF GEOMETRICAL DETERIORATION OF TRAMWAY TRACKS

Purpose. The authors' aim is to demonstrate their results of analysis of deterioration of tramway tracks' geometry. **Methodology.** This article is a start of a PhD research. At first, the superstructure systems and the used instrument were summarized, after that the examination of running track, tramway stops, crossings and turnouts. **Findings.** The authors examined separately the running track, tramway stops, level crossings and turnouts. In case of examination of running track, we evaluated the measurement results according to two methods. To clarify the superstructure systems' deterioration factor the authors had to do further measurements on other tramway lines too. **Originality.** The fulfilled analysis is the first step to the complex method that can consider and determine the optimisation of life-cycle costs of tramway superstructures. For this goal a lot of parameters, factors have to be taken into consideration in the future. There are available methods and models for different civil engineering areas, e.g. there is very complex methodology related to road pavements, but there is no special one related neit

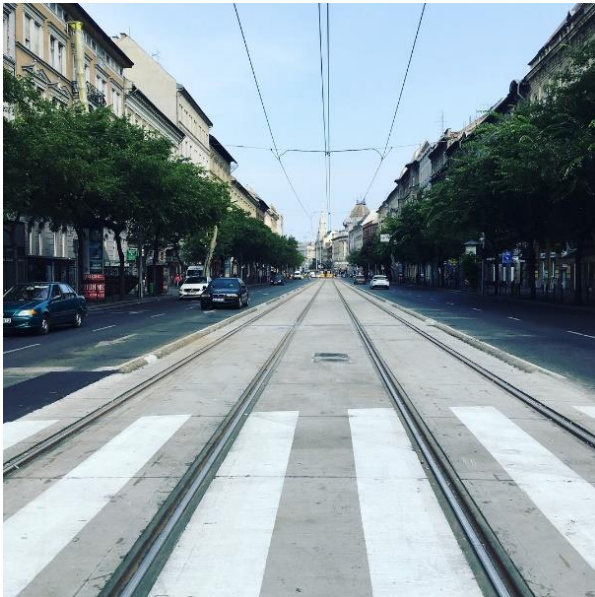
Fig. 12. ESCRB III. track system

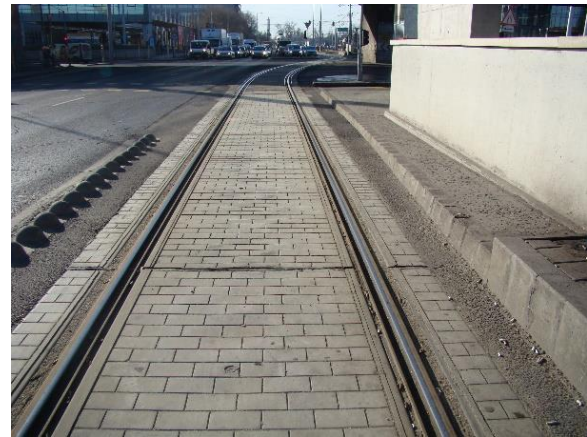
Fig. 14. «Large slab» superstructure

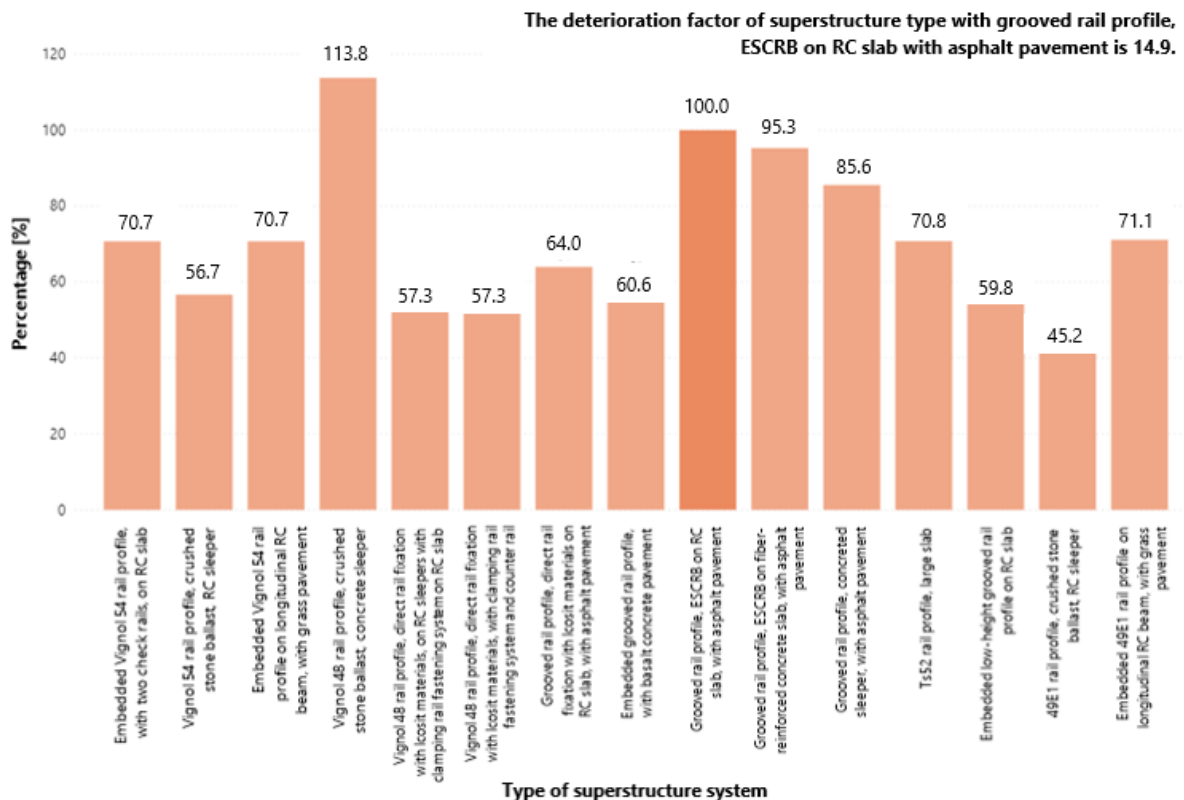
The analysis of the measurement results shows that as in case #1, the deterioration of the superstructure type constructed with Vignol 48 rail profile, crushed stone ballast, and concrete sleepers has the highest value – 14% higher than the benchmark grooved rail profile, ESCRB on RC slab, with asphalt pavement superstructure system (Fig. 18).

Fig. 18. The percentage of deterioration factors relative to each other – second version

Comparing the results from cases #1 and #2, it is noticeable that by modifying the parameters, the values of deterioration factors for each superstructure system have also been modified (Fig. 19). This can be explained by the fact that these superstructure system types are only found in small lengths over the entire tramway line, but many defaults have occurred since they were constructed.
